Activity and Recommendations Report

Nature Foundation St Maarten (NF)

Activity name: Mangrove removal Zagersgut and Fresh pond

Date: 22nd of September 2021

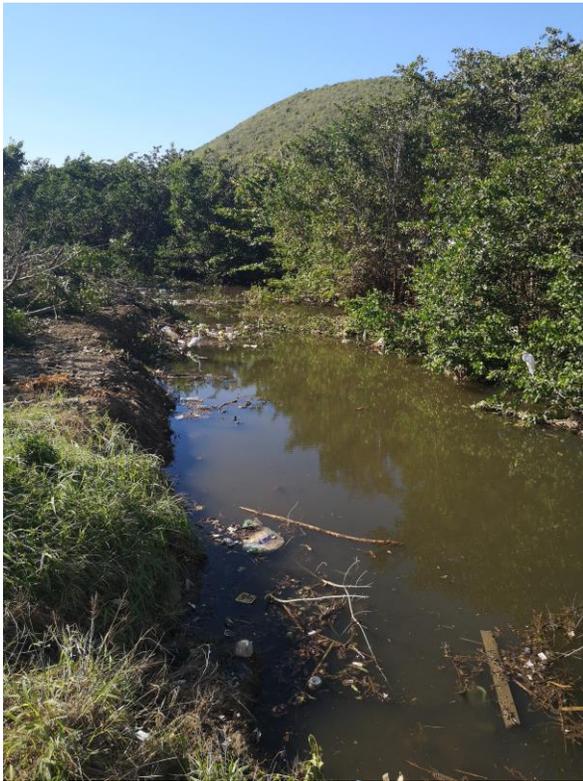
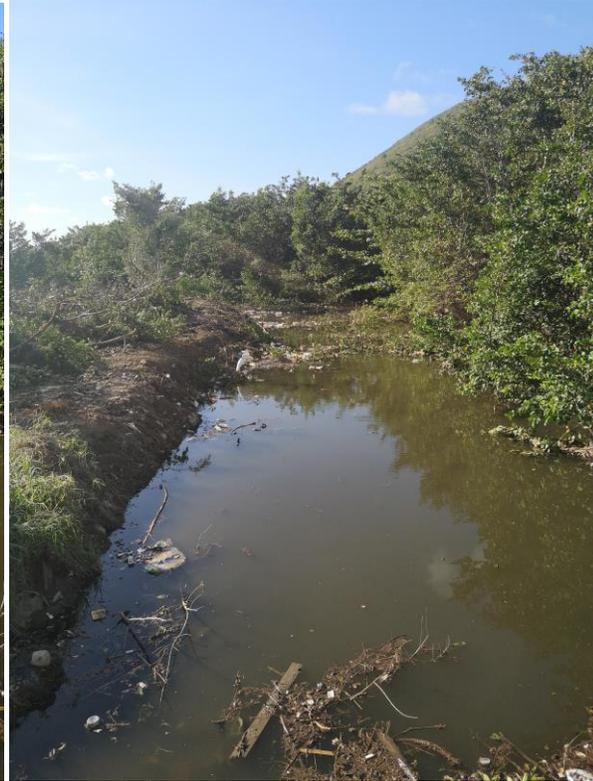
On the 22nd of September Nature Foundation met with the VROMI Infrastructure department on the location to discuss the concerns and current removal activities. Upon arrival it was established that mostly white mangroves (*Laguncularia racemose*) were located around the pond and Zagersgut channel, several of those mangroves were already removed by VROMI as can be seen on the pictures. Large amounts of trash and garbage were recorded in the water ways and in between the mangroves, mostly single use plastic products.

White mangroves removed at the channel of Zagersgut by the Bridge.

- Much of the water flow is decreased due to large amounts of trash and garbage. It is strongly recommended to have a contractor remove all trash and garbage in and around the pond and mangroves. Hereby the water flow will increase, and less sediment will be trapped over time.
- It is recommended to not remove or uproot the white mangroves and minimize tree uprooting or removal activities as much as possible.

- Avoid and minimize unnecessary damages to the white mangroves and other trees.
- Rather apply branch trimming techniques instead of removal activities, in order to eliminate excessive growth of mangrove branches which cause the water flow to decrease. Keep root systems of white mangroves intact and follow trimming recommendations as much as possible.

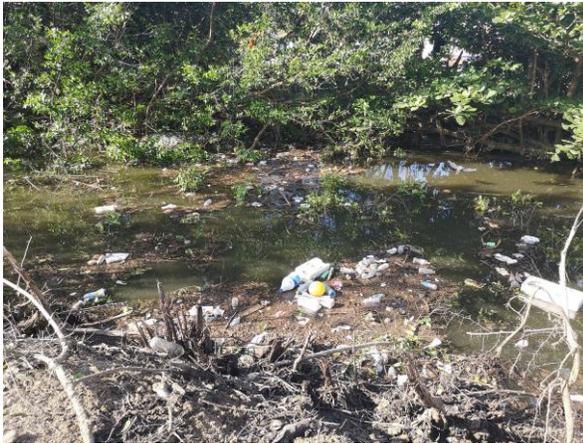
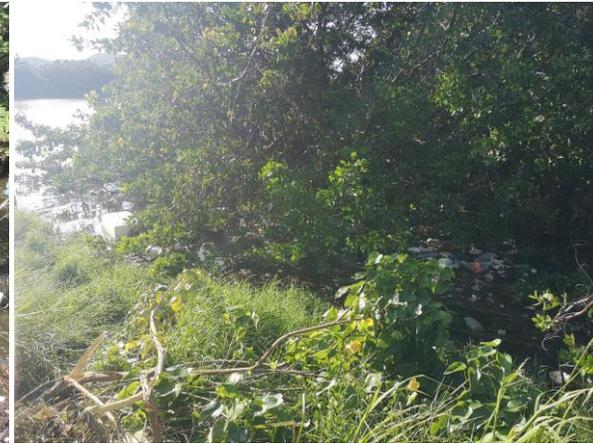
VROMI explained the need to remove the mangroves, as the water from Cul de Sac is stagnating due to the sediment slip building up, trash being trapped and the vegetation growth. NF explained that the large amounts of trash and garbage need to be removed and cleaned, as this is a significant cause hampering the water flow. Also, some of the mangrove trees need to be trimmed to increase water flow, often removal may not be needed as the white mangrove roots are mostly located on land and not in the pond itself. The mangroves are also important as they filter the water and increase the quality, considering the large amount of pollution and trash, water filtering by mangroves is much needed. An abundance of important bird species are using the area, especially the mangroves and pond water, therefore it is important to keep most of the mangroves intact and decrease removal as much as possible. The mangroves decrease disturbances for birds and contribute to their health, feeding and nesting success

Large amounts of trash and garbage at Zagersgut and the Fresh Pond.

- Remove bird nests before trimming and tree removal activities.
- Install trash catchments (traps) in the water ways flowing into zagersgut and the Fresh Pond, to prevent garbage to end up in the pond. These catchments or traps need to be empty regularly, especially during hurricane season and rainy periods.

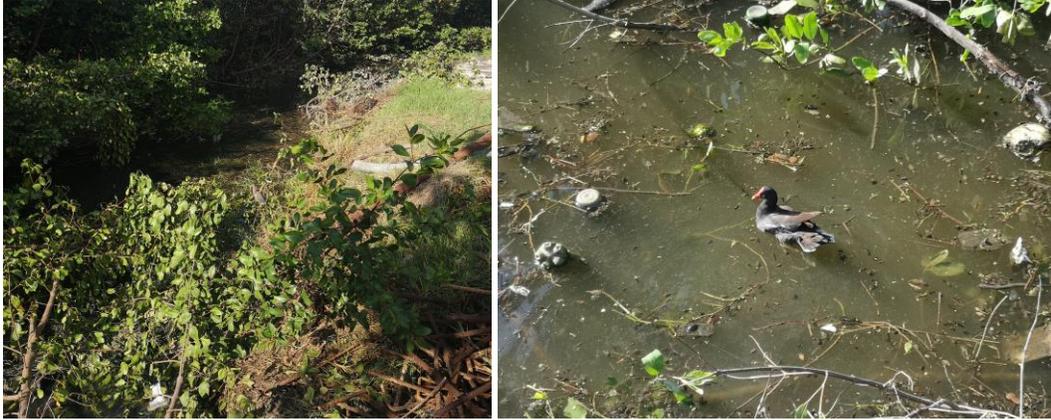
In between the mangroves multiple bird species were found using the area, resting or feeding, such as common moorhens with babies, black-crowned night heron, great egret, bananaquit, great blue heron, and green heron. Red-eared slider turtles were found in the gutter beside the zagersgut channel, but upon attempting to remove the turtles they all disappeared. The gutter probably was in connection with the pond and the turtles were able to swim in and out.

Different bird species present in the pond and waterways, Black-crowned night heron and Common Moorhen.

- Whenever possible follow the Nature Foundation recommendations for mangrove trimming for St. Maarten listed below.
- Several different bird species reside in the mangrove trees, in case of mangrove trimming or uprooting, provide sufficient time for these species to leave the area safely.

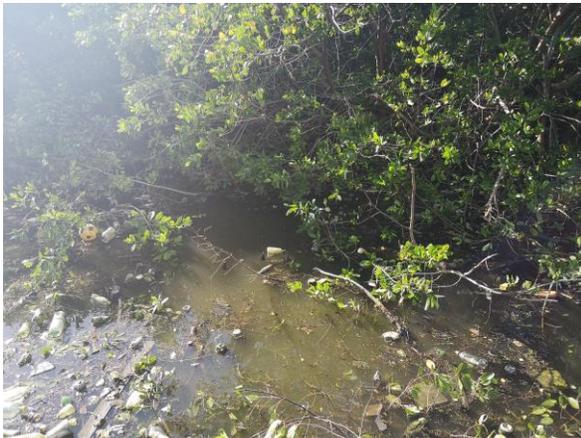
Much trash located in between the mangroves, behind the church, and several baby Common moorhens using the pond and mangroves.

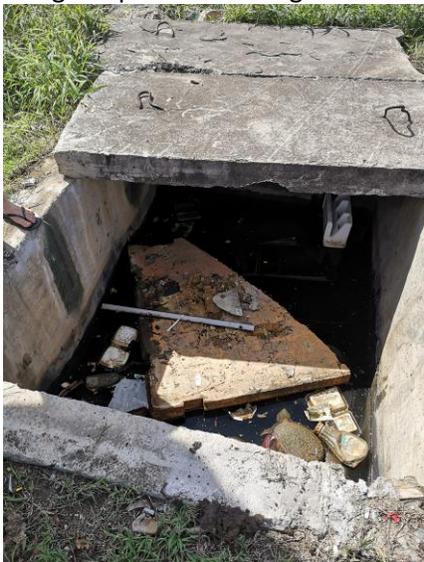
Gutter where slider turtles were seen in.
